AFMAL-TR-83-4154

CONFERENCE ON AEROSPACE TRANSPARENT MATERIALS AND ENCLOSURES

December 1983

Conference Report for Period 11-14 July 1983

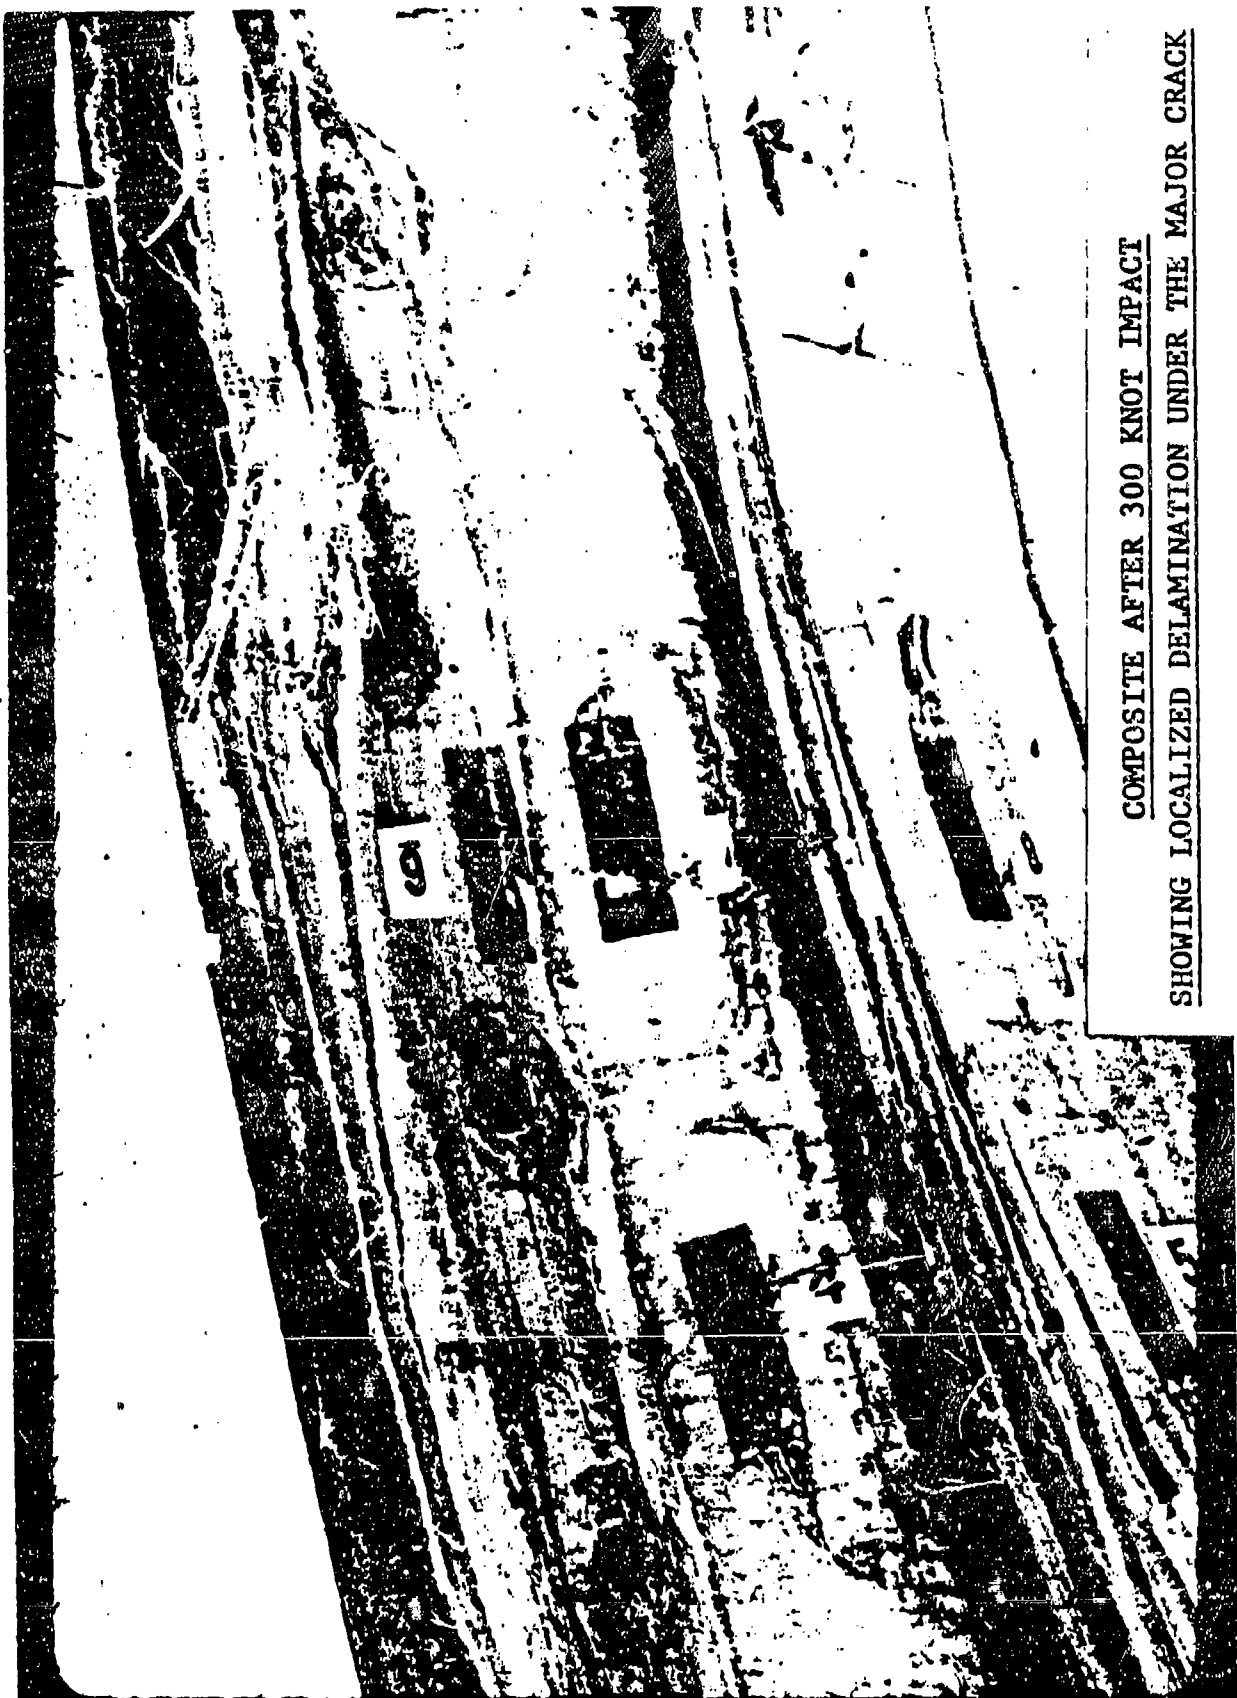
COMPOSITE AFTER 300 KNOT IMPACT
SHOWING LOCALIZED DELAMINATION UNDER THE MAJOR CRACK

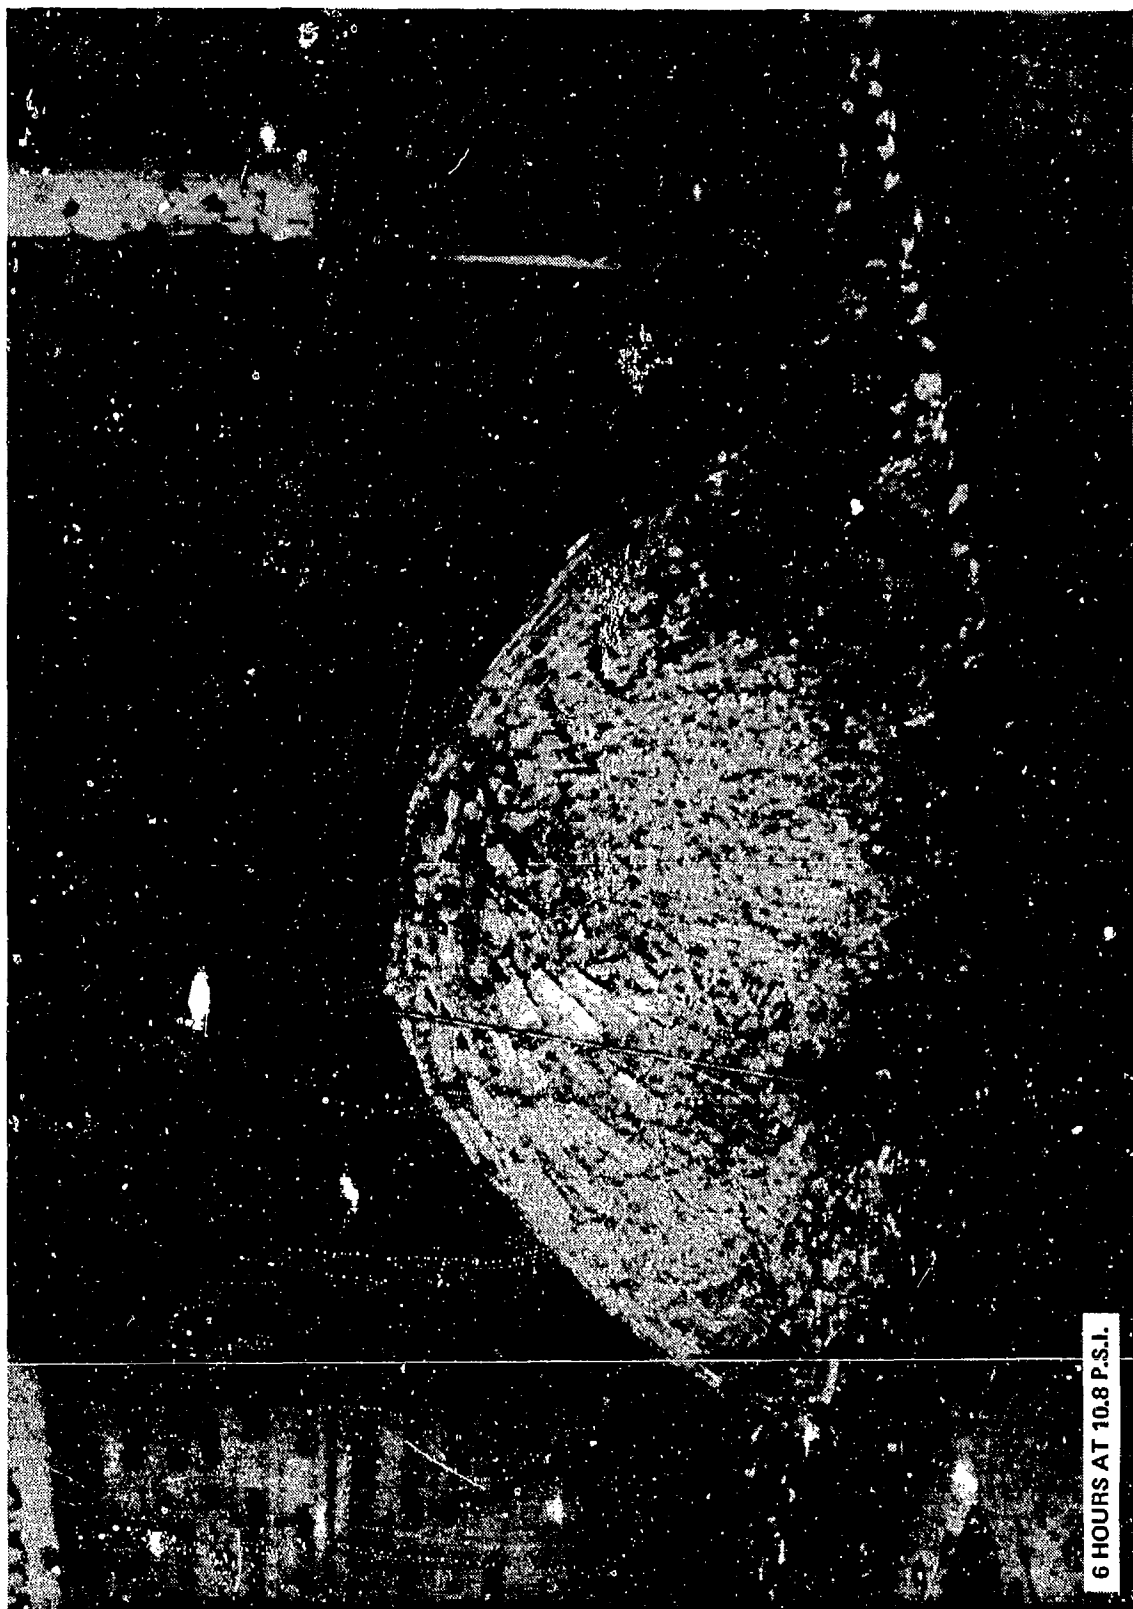
Figure 19 - Windshield Failsafe Pressure Test

Standard luminous transmittance before and after U/V exposure, in addition to thermal effects and thermal shock tests, were conducted on test specimens and full size windshields by PPG and Sierracin. All units passed the test successfully. Sierracin also conducted the ball drop impact test on a full size windshield and a pressure fail-safe test on a windshield (with all glass plies intentionally broken, at a pressure of 10.8 psi for six hours). Figure 18 and 19 show photographs of these tests.

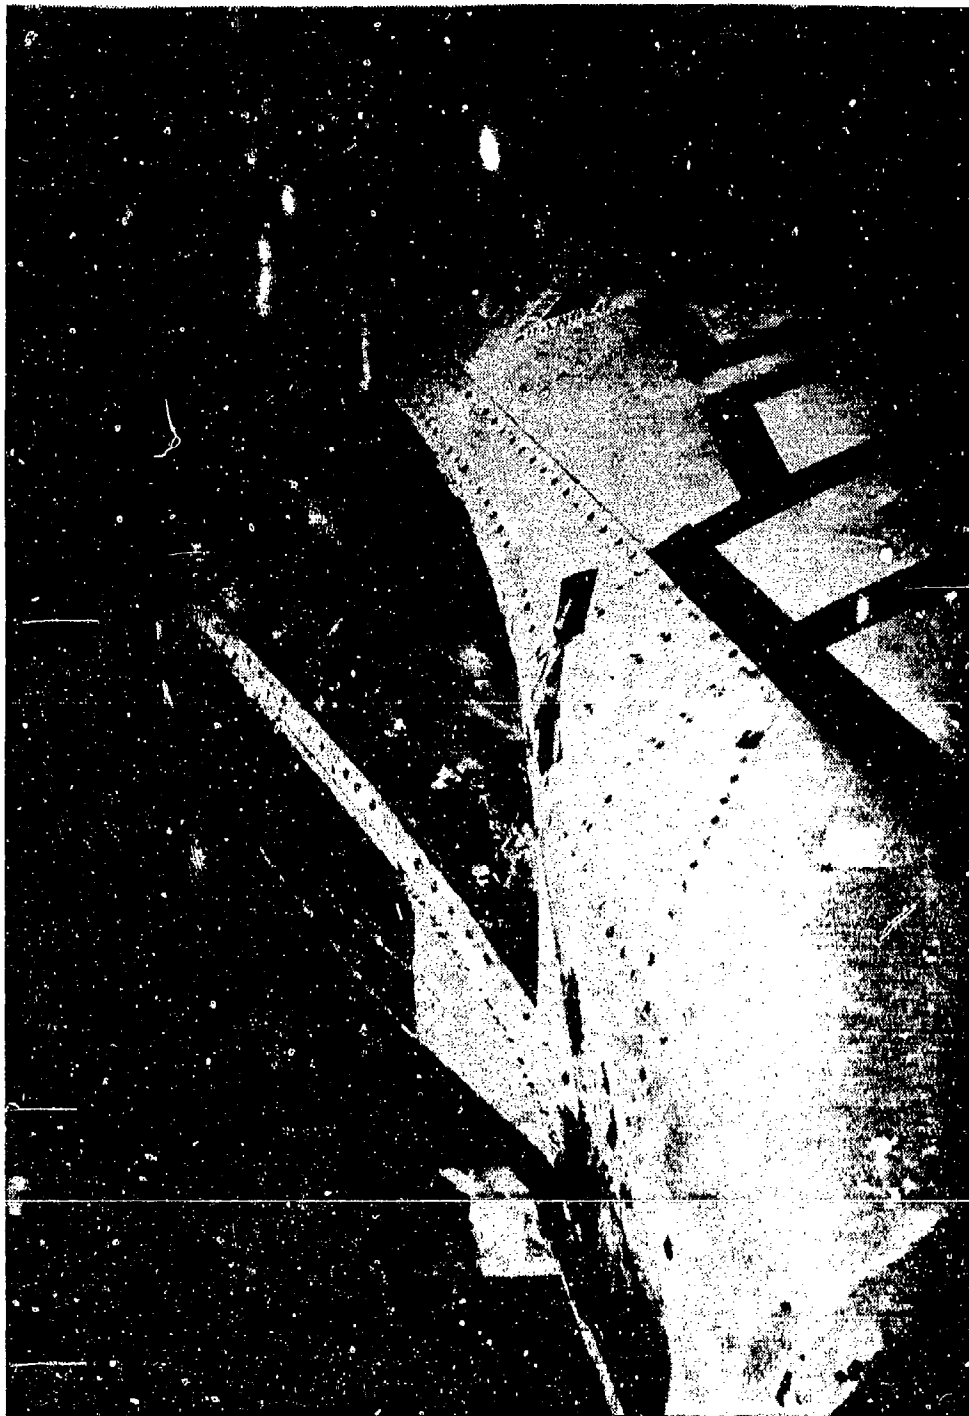
Figure 10. Post Test Damage, 200 Knot Impact on Windshield Side Panel.

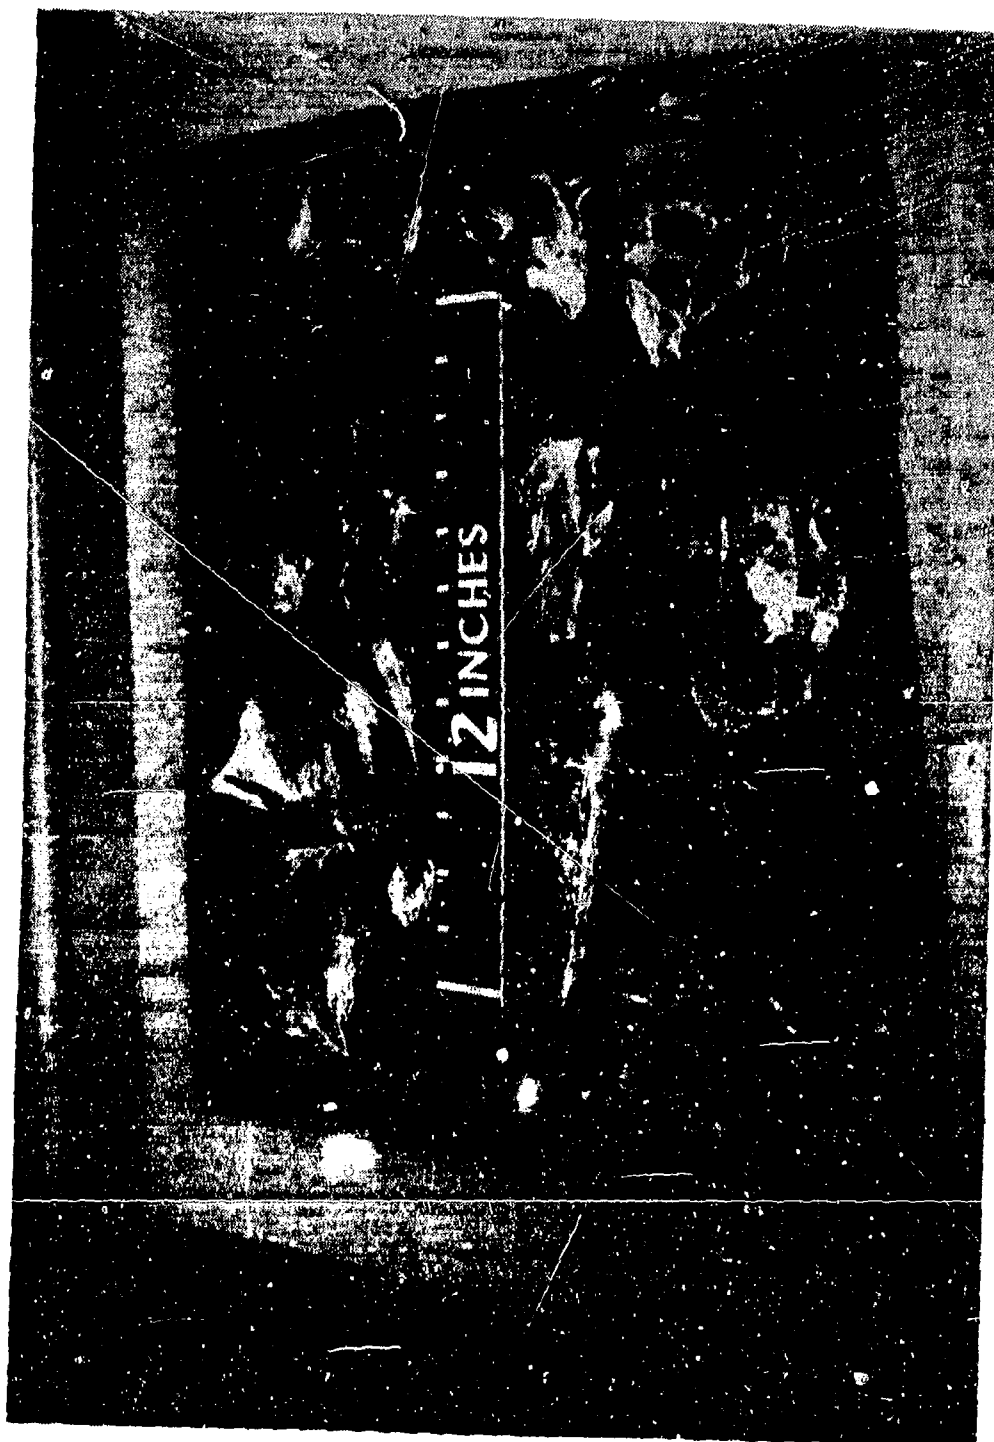
Figure 11. Typical Spalled Acrylic from Windshield Side Panel.

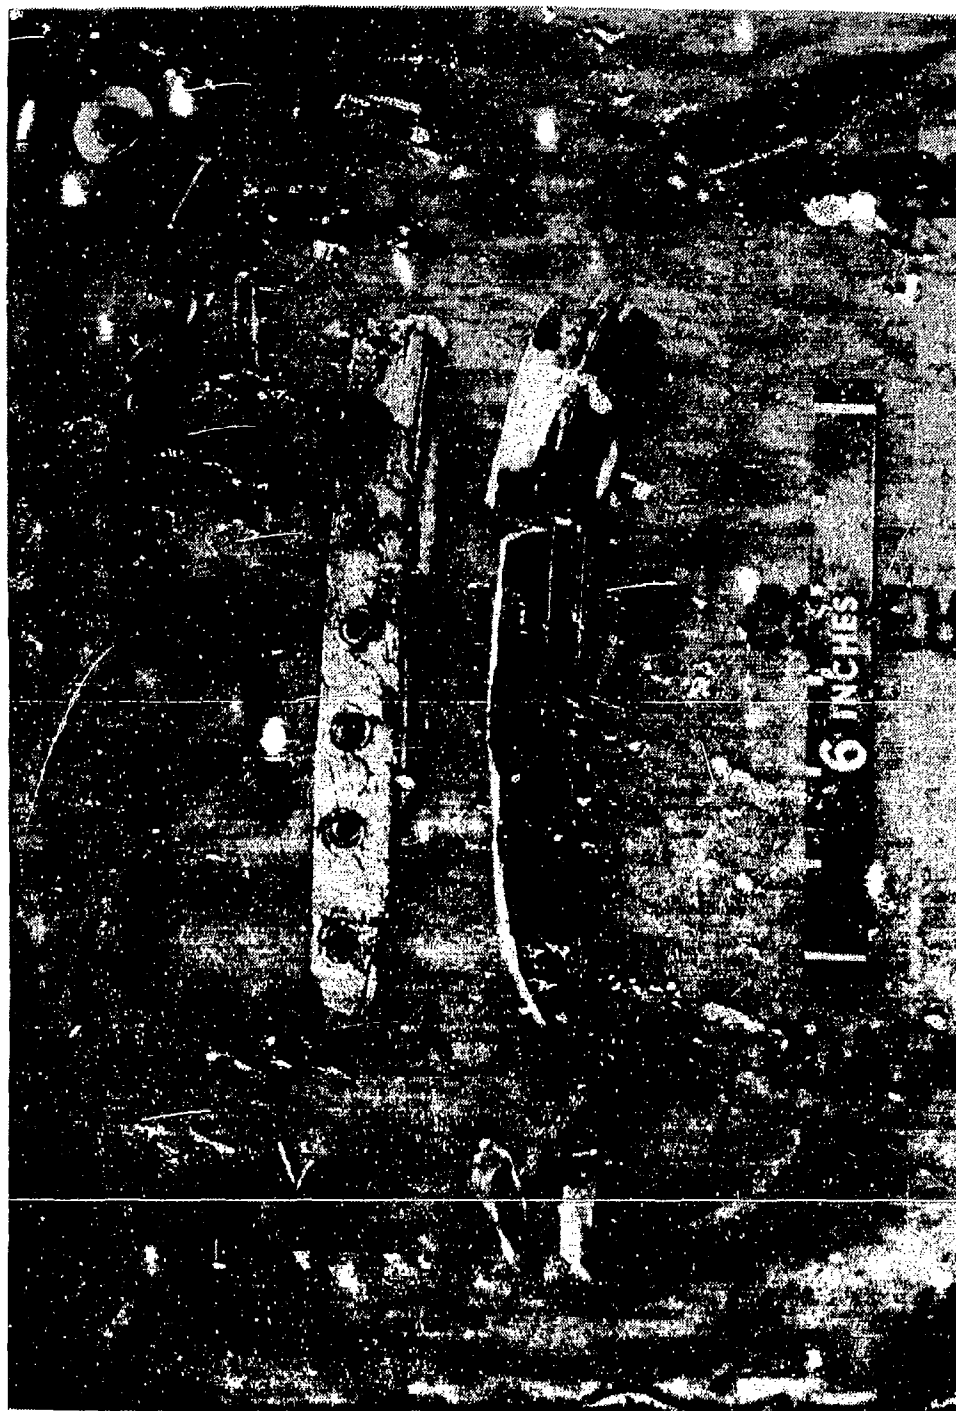
Figure 16. Failed Windshield Arch Fragments After 450-knot Side Panel Impact on Laminated Side Panel.
